NEW YORK STATE DEPT OF ENVIRONMENTAL CONSERVATION ALBANY F/6 13/2
NATIONAL DAM SAFETY PROGRAM. VLY CREEK DAM, INVENTORY NUMBER NY--ETC(U)
SEP 78 @ KOCH

LOWER HUDSON RIVER BASIN
WLY CREEK DAM
NY 96 & NY 97
PHASE I INSPECTION REPORT

PHASE I REPORT
NATIONAL DAM SAFETY PROGRAM

Name of Dam: Vly Creek NY 96 & 97 Lower Hudson W.S.
(DEC #208-2378 & 208-2379)
State Located: New York
County Located: Albany
Stream: Vly Creek (tributary of Coeymans Creek)
Date of Inspection: [CONT'D FROM PAGE 1] July 13, 1978

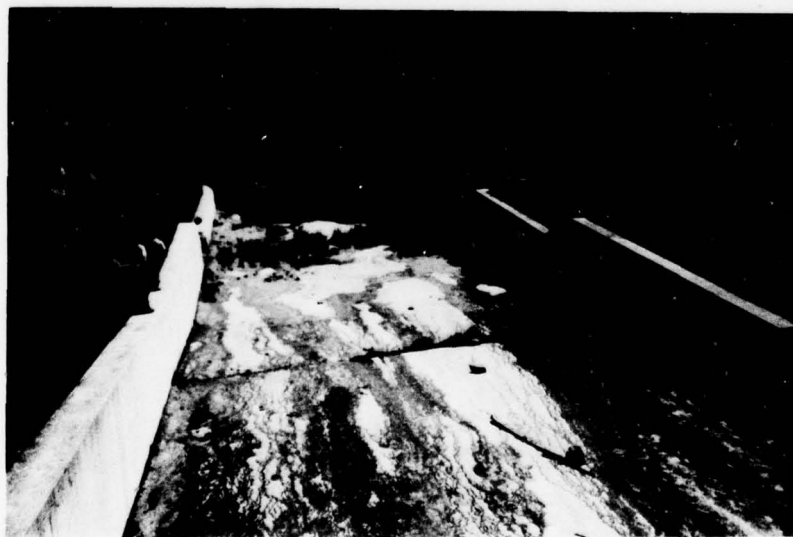
In general, the spillway is in poor condition. The spillway walls were cracked at both abutments and at the construction joints.

Considerable debris was found in the tailrace channel and at the end of the spillway chute. Vegetation was growing through the expansion joints of the spillway slabs. No energy dissipation was provided at the end of the spillway.

Spillway Chute and Downstream Channel
looking south

d. Condition of Tail race channel considerable debris in
tail race channel, ie algae rocks logs and clumps
of vegetation - growth in joints of concrete slab

- b. All debris in the spillway chute and the tailrace channel must be removed. All vegetative growth in the channel must be removed and periodically maintained in that manner. Vegetation below the toe of the embankments should also be regularly trimmed back to permit unimpeded inspection of this area. Additional growth observed in the riprap should be removed.

- c. Riprap should be placed in the tailrace channel after debris removal to prevent scour and undermining of the spillway.
- d. All joints in the spillway must be cleaned and recaulked. All concrete cracks must be cleaned and repaired, with particular attention paid to sealing of horizontal cracks and joints.
